**IMECE2007-41518**

**HAIL EFFECTS ON AIR-CONDITIONER PERFORMANCE**

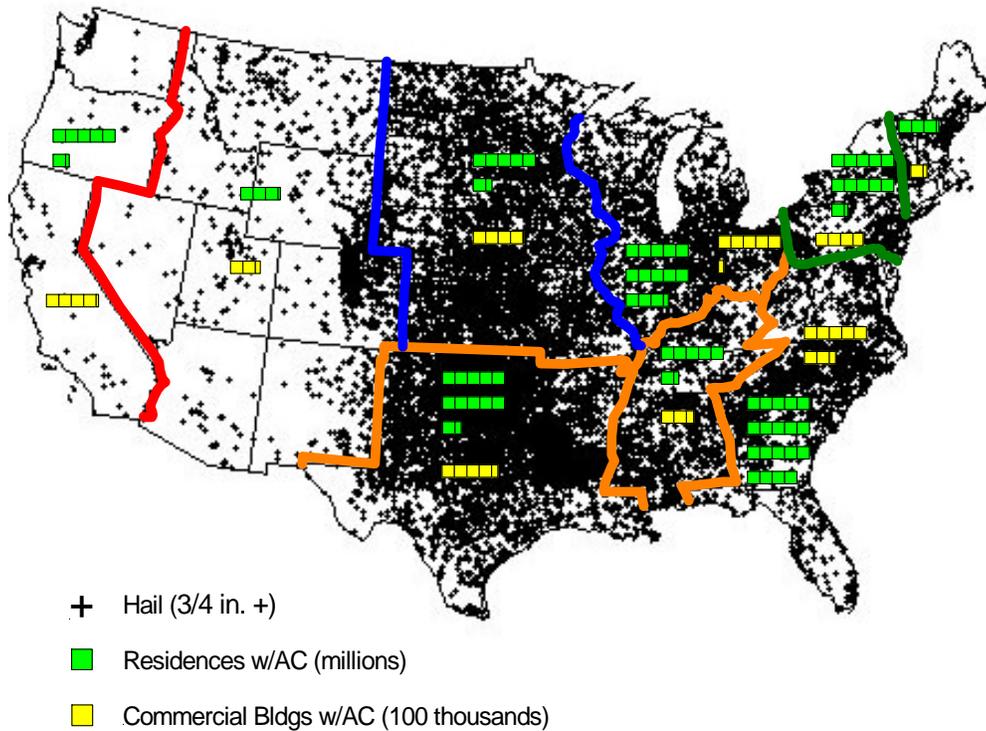
Figure 1. Locations of hailstorms with  $\frac{3}{4}$  inch (19.1 mm) and larger hail from 1981 to 1990 [4]. Overlaid on the hail map is the number of residences and commercial buildings with air-conditioning by region [2,3].

The number of air-conditioners found in any locale can be attributed to two primary factors: population and climate. The influence of climate is measured by the number of cooling degree days per year. Unrelated to air-conditioning, but very much governed by weather, is the occurrence of hail. Much of the continental United States experiences hail. Areas east of the Rocky Mountains, particularly southwestern and midwestern states are especially prone. It is in those areas that warm moist air from the Gulf of Mexico collides with cold air from the north, creating conditions that favor hail. Figure 1 is a map of the United States depicting locations of all reports of hail  $\frac{3}{4}$  inch (19.1 mm) in diameter and larger from 1981 to 1990 [4]. Included on that same map is a breakdown by geographical region of the numbers of residences and commercial buildings with air-conditioning. From the map it is readily apparent that hail-prone regions have many air-conditioned buildings.

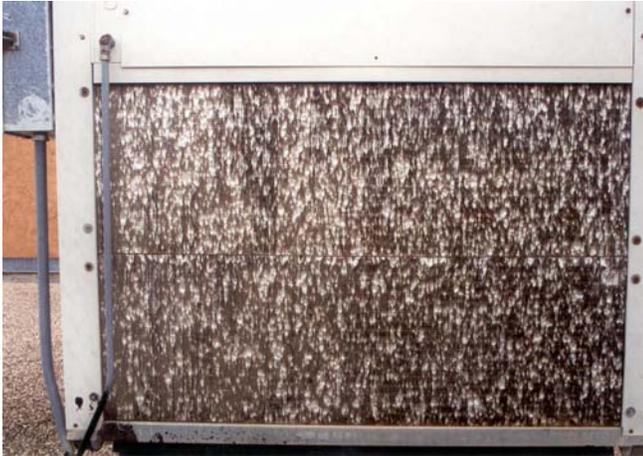
**Figure 2. Condenser coil fins of a rooftop air conditioner that were dented by hail.**

inch (3.1 and 7.9 fins per centimeter). The thin cross sections of fins serve well to conduct heat from the refrigerant in the coils and transfer it to air passing by them. But these fins are easily bent. Impacts by even small hailstones fold the fins over. Figure 2 is a photograph of an air-conditioner with hail-dented fins.

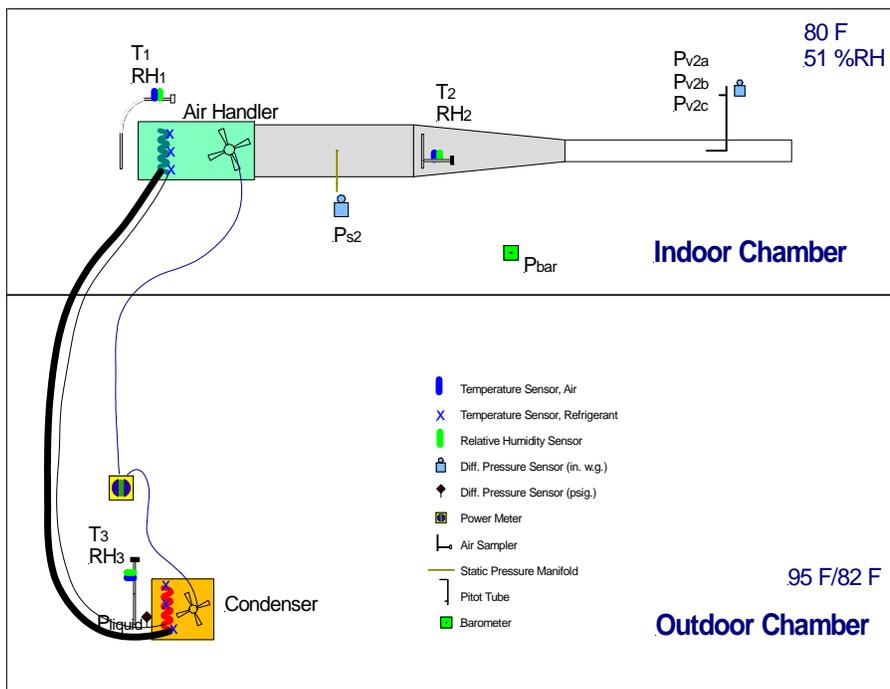
**Figure 3. Schematic of test setup for measuring the performance of an air-conditioning system using the Indoor Enthalpy Method.**

evaporator and condenser coils were monitored throughout the tests. Figure 3 is a schematic of the test setup for the Indoor Enthalpy Method. Additional ducts, instrumentation, and a fan were added to the condenser outlet for usage in the Outdoor Enthalpy Method. Figures 4 and 5 are photographs of the laboratory setups.

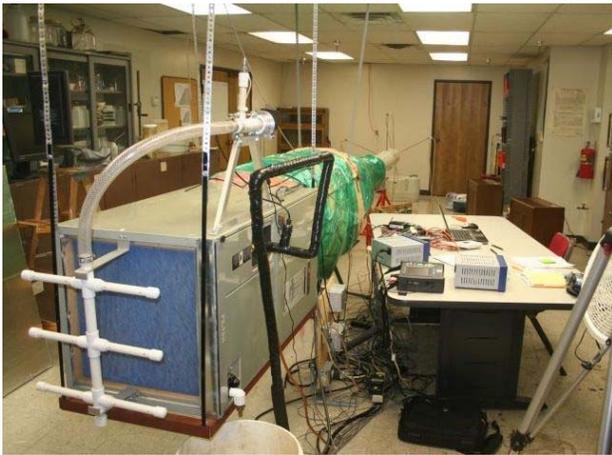
Figure 4. Indoor chamber with air handler, duct, flow measuring device, and instruments.

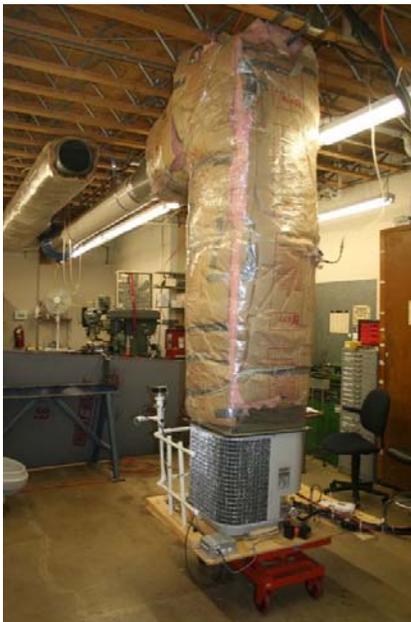
Figure 5. Outdoor chamber with condenser, duct, flow measuring device, fan, and instruments.

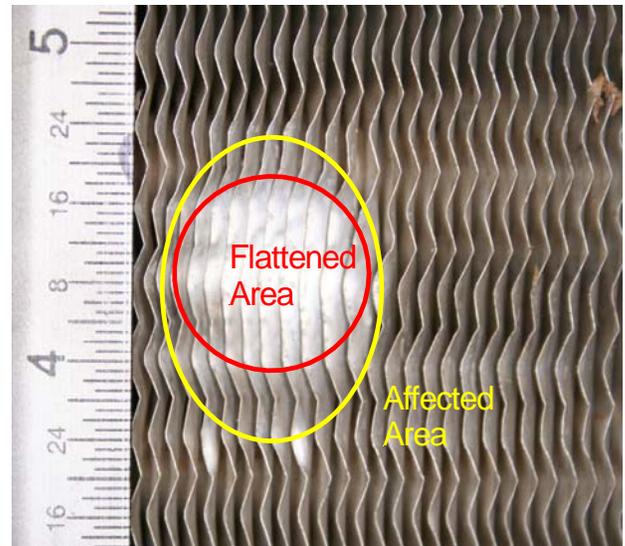
Figure 6. Typical dent in condenser coil fins. The affected area is elliptical in shape (yellow ellipse). The fins are flattened completely within the center of the affected area (red circle), where the denter contacted the fins directly.

Dents were formed by manually pressing the denting tool (denter) against the fins. The denter was pressed inward until it flattened fins against the coil. Regions of fins affected by pressing the denter inward were elliptical in shape. The fins were flattened completely in a circular portion of the affected area. Figure 6 is a photograph of a typical dent. The elliptical affected area and circular flattened area are marked for clarity. On unit 1, flattened areas for each dent averaged 0.40 in.<sup>2</sup> (258 mm<sup>2</sup>). On unit 2, flattened areas for each dent averaged 0.46 in.<sup>2</sup> (297 mm<sup>2</sup>). The denter was utilized until ultimately every square in the guiding grid had been dented. To facilitate greater flattened areas, entire sections of the fins were folded over and flattened by hand.

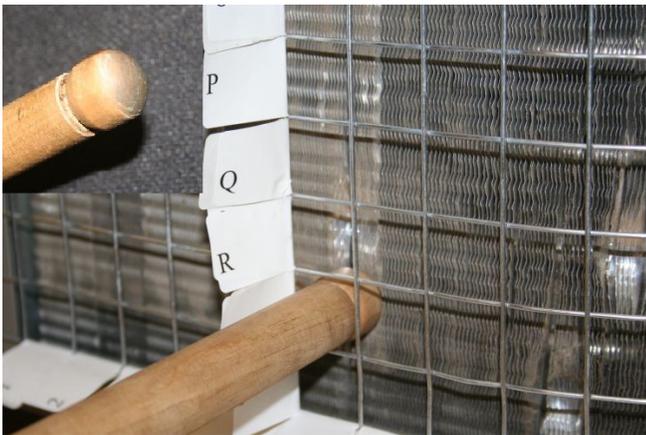
**Figure 7. Denter and wire grid. Inset is the rounded head of the denter.**

A wooden dowel with a hemispherical head on one end, 1/2-inch (12.7 mm) radius, was used to dent the fins. Welded wire with a 1-inch (25.4 mm) mesh stretched over the front of the condensers provided a grid for locating the dents. Each square of the welded wire grid was assigned a letter and a number. A random number generator selected the pattern in which the fins were to be dented.

As built, steel louvers surrounded the condenser coils of both units tested. The units were tested initially with their louvers, then the louvers were removed to expose the coils and the units tested again. Next, dents were made randomly in the aluminum coil fins. Successive tests were performed with increasingly greater numbers of dents until every square of the wire grid had been dented. With every grid square dented, 41% to 45% of the fin areas were flattened. The remainder of the fin area was deformed but not flat or unaffected altogether. To increase the flattened fin area beyond the denter's capability, entire columns of fins were folded over mechanically so that no gaps remained between fins in those areas. Columns of flattened fins were added so that 60%, 80%, and 100% flattening resulted. The 100% flattened condition eliminated nearly all airflow through the condenser. Tests measured capacities and efficiencies of the assemblies for each condition. Finally, the fins were combed and the performances measured again. Figure 7 is a photograph of the denter and the welded wire grid. Figure 8 shows several dented conditions for which tests were run.

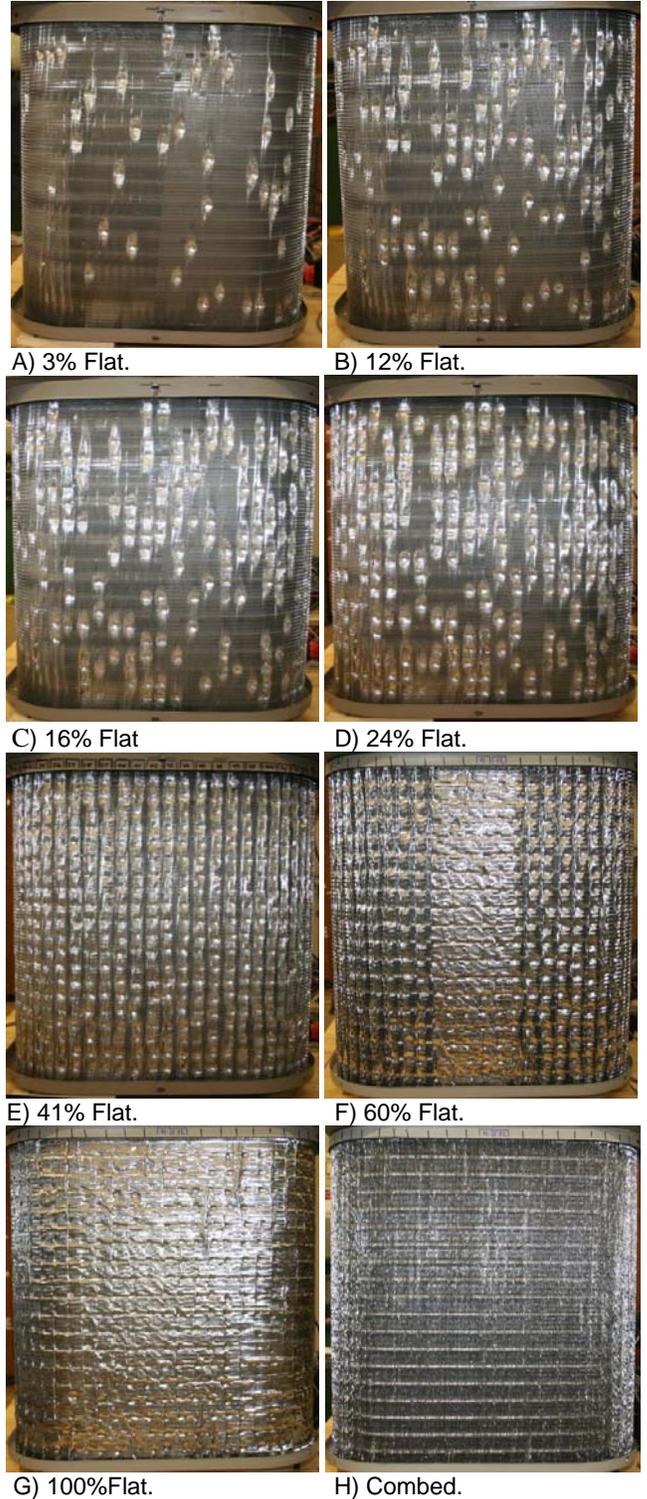
**Figure 8. Dented coil fin conditions.**

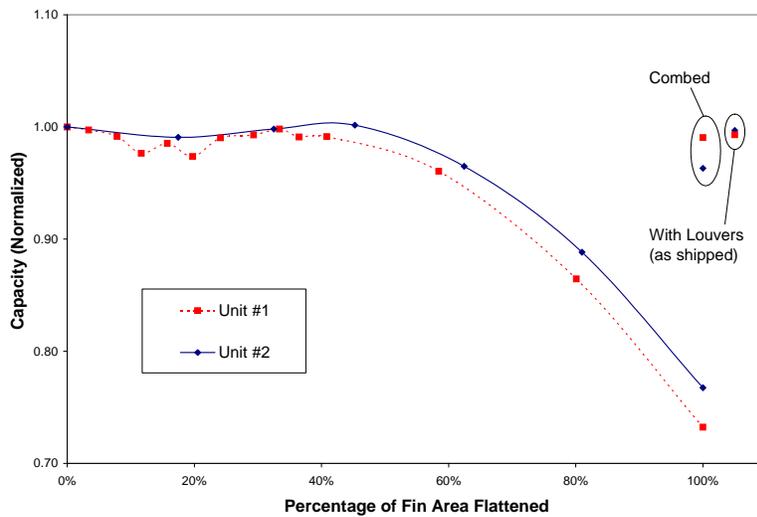
Figure 9. Effects of Fin Dents on System Capacity.

Denting air-conditioner fins in discrete circular regions throughout the coils had little to no effect on the capacities of the units, even with 41% of the fin areas completely flattened. Beyond the discrete dents, folding columns of fins so that 60% of the condenser areas were flattened caused the capacities to drop 4%. Flattening all of the fins, thereby eliminating nearly all airflow across the condensers, reduced the tested unit capacities 23% and 27%.

Figures 9 through 12 depict the capacity, EER, SEER, and power consumption for both condenser units tested. Test conditions included the as-shipped construction (with louvers on), exposed coils with a wide range of dents (with louvers off), and exposed coils after combing.

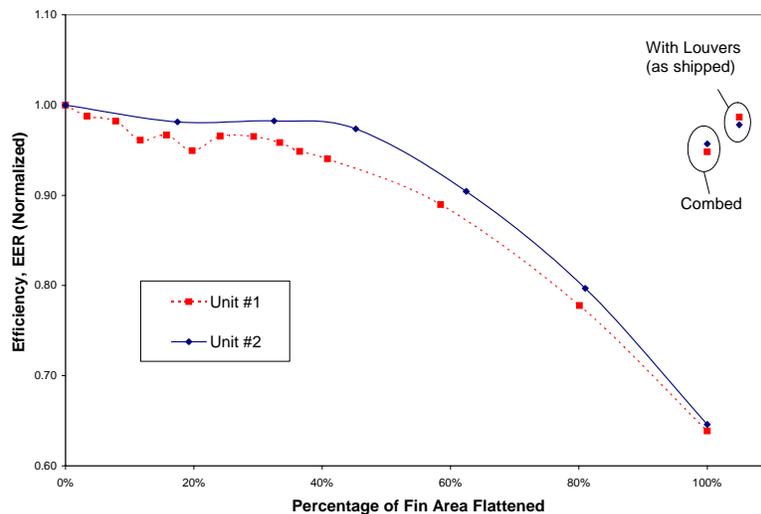
Figure 10. Effects of Fin Dents on Energy Efficiency Ratio (EER).

Denting the fins caused reductions in air-conditioner efficiency. The SEER of both units was reduced 34% in the extreme condition of the coil fins flattened completely. With discrete dents on the entire coil surface (the 41% flattened condition), the SEER of one unit dropped 5% and the SEER of the other unit dropped 2%. With the fins completely flattened, EER decreased 35 and 36%. In the 41% flattened condition, EER decreased 3 and 6%.

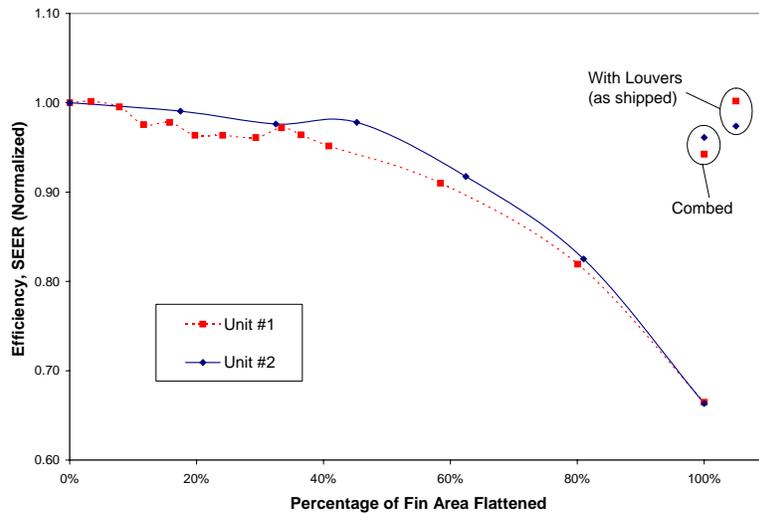
Figure 11. Effects of Fin Dents on Seasonal Energy Efficiency Ratio (SEER).

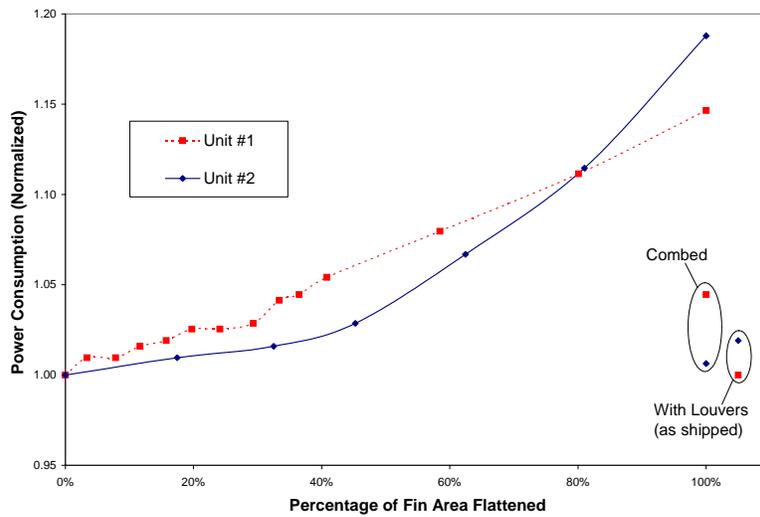
Figure 12. Effects of Fin Dents on Power Consumption.

Incremental increases in percentage of area dented caused incremental increases in power consumed by the systems. With all of the fins flattened, power consumption increased from the undented condition 15% for unit 1 and 19% for unit 2. With the entire coil surface covered with discrete dents (the 41% flat condition), the power consumption of one air-conditioner increased 5% and the other increased 3%.
